RFI Modification

06/04/98

Any ProTek unit experiencing RFI on-site

All firmware versions

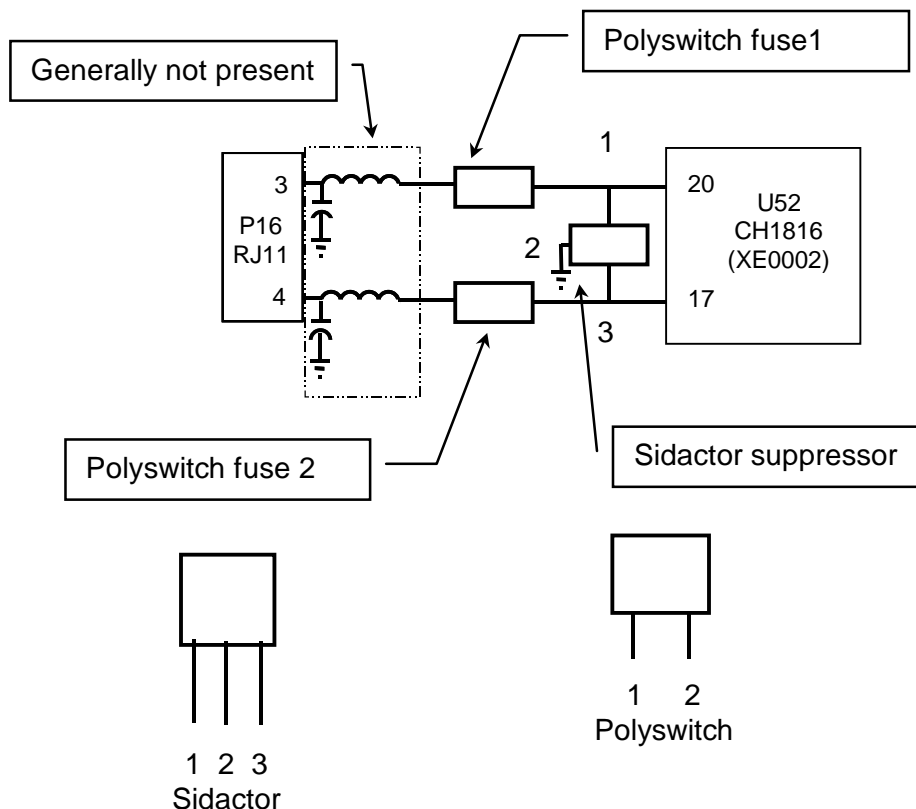
Erratic phone connection at site though unit operates normally on the bench during initial check out and programming. Symptoms may include random erroneous characters upon connection, 300 baud only operation, or occasional unexplained disconnection

- 1 Add .001uf capacitors rated at 1500V from P16 pin 3 to ground and from P16 pin 4 to ground. The most effective location for these capacitors will be on the bottom of the PCB from the RJ11C to the ground bus immediately adjacent to the connector.
- 2 Cut the two traces on the component side of the PCB between the RJ11 jack (P16) and the DAA (U52). Score the traces using the side of the U52 as a guide. The foil can be neatly cut with a razor knife and the foil peeled from the board.
- 3 Install the two coils on the bottom of the board as indicated below. For the CH1817 connect one coil between P16 pin 3 and U52 pin 1 and the other between P16 pin 4 and U52 pin 2. The added components are **bolded** on the diagrams below. *If you are modifying an older ProTek with the CH1816 or XE0002, please notice that the CH1816 pin outs are different from the CH1817 pin outs.*
